DIYers simple oil change nightmare

By Clinton Brett

VDJ79 series

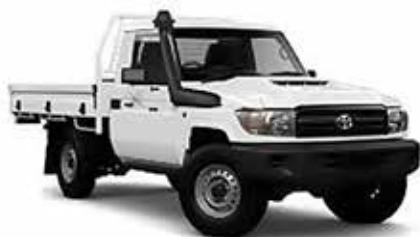
The 2018 VDJ Landcruiser with 166k had been recently serviced by the owner himself prior to faults and symptoms appearing. The customer had not mentioned any work prior to it arriving at our member's workshop on the back of a tow truck. Needless to say they were a bit embarrassed and not forthcoming of their home servicing mistake.
