Subaru Diesel Secondary EGR Fault

By Clinton Brett

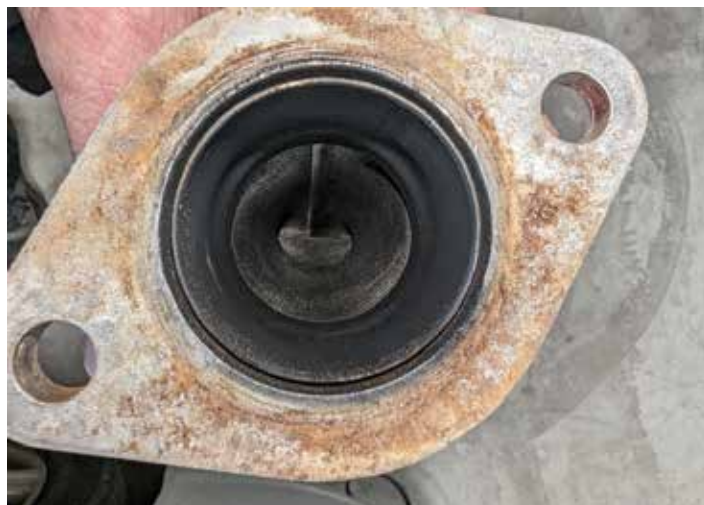
LP EGR gauze

One of the key features of this LP EGR is a fine gauze fitted in between the DPF and the EGR itself. The stainless steel gauze filter reduces excess carbon build-up around the EGR valve and EGR cooler. This can extend the service schedule for intake manifold cleaning.

Unfortunately, this service does not occur very often and the gauze easily becomes blocked, triggering a P049B EGR B Flow insufficient fault code and the vehicle goes into derate status as a result of this code. By the way, using any on-vehicle intake clean is not the correct service method. Anyone with diesel knowledge and experience would be well aware this cleaning process has no chance of getting close to the EGR and in several cases, has created the opposite effect—blocks this LP EGR.

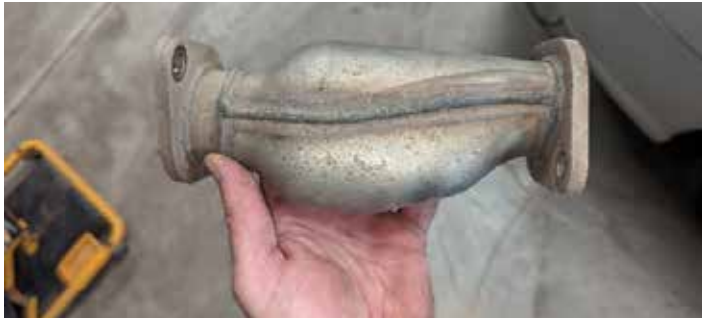
EGR connecting pipe

EGR B as it's known on the Subaru, has several lengths of steel tubing to direct the flow. One section of this tubing contains a fine gauze filter. This section has been described to look similar to an exhaust cat convertor, see picture.

When diagnosing this fault code, we advise to check this gauze first for any restriction. To locate this section, follow the EGR

bypass pipe from the passenger side across to the driver's side and you'll find the small cat converter design with a 2 bolt flange on either end. See pic of filter section removed.

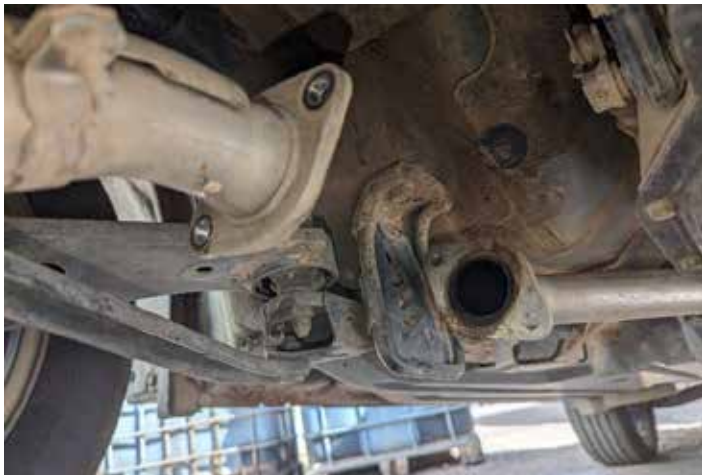
Section removed under car

Remove and inspect for blockage. The filter is a fine stainless steel mesh and a quick confirmation can be done by pouring water into one end and observe if the water flows from the opposite end. If it is a slow flow, then it's restricted. Excess carbon and soot can be seen in the image.

Solution: Clean the section with a reputable cleaner. We don't make a habit of endorsing products but we do recommend TUNAP 925 EGR system cleaner as it works very well.

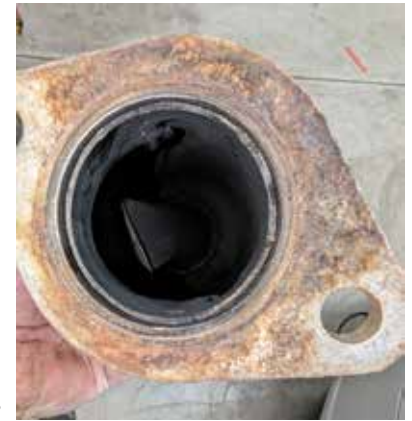
Blocked gauze

On a side note, for some time our Diesel Help Members have successfully cleaned this filter without a return fault. That was until we experienced a repeat offender. The vehicle returned after a week of driving approximately 500kms. The gauze had blocked very quickly and required removal and cleaning again- 3 times in 2 weeks. Further investigation found that this vehicle had a new DPF fitted by the local Subaru dealer BUT, for some strange reason, the dealer opted for an aftermarket DPF over their OEM preferred DPF.

With this and another repeated offender case, we came to the conclusion that the aftermarket DPF was not sufficient for this engine and was allowing excessive soot to pass through the DPF substrate filter. This would also mean it's possible that the DPF is not doing the task required, ie Reducing Emissions. Adding fuel to fire, in one of these cases, the technician opted to remove the gauze. This of course is going to lead to other issues down the track- Blocked EGR cooler, EGR clogged and intake restriction. It's going to require a more expensive repair and possibly damage in the long run.

If it's a high km car and DPF condition and intake manifold condition is unknown then it would pay to clean these also. The MAP sensor has been known to build up with excessive carbon too and must be removed and inspected. If severe, do not clean the MAP sensor, replace with genuine only. The MAP sensor is located in the bottom section of the 2 piece intake manifold. It is important that both upper and lower intake manifolds are removed and thoroughly cleaned.
