Isuzu Exhaust Brake Failure Causes DPF Fault

In this article the model we are working with is the Isuzu N series fitted with the 4JJ1-TCC engine 2009 to 2018.

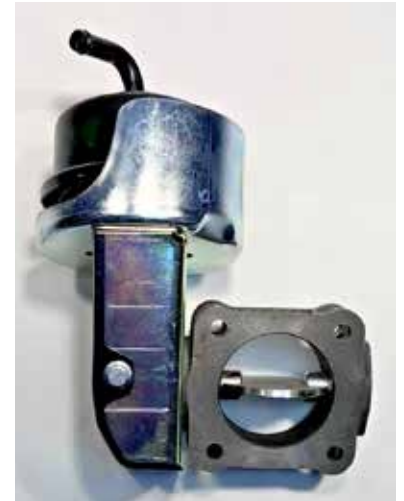
Basically, exhaust brakes are used to assist slowing down the truck by restricting the exhaust when you let the foot off the accelerator pedal. This pedal has a microswitch beneath and would activate. There is also a similar switch located on manual gearboxes beneath the clutch pedal, so that whenever you applied the clutch to change gears, this switch would momentarily disengage the exhaust brake preventing the engine from stalling.

Exhaust Brake

The failure in this case was the diaphragm in the exhaust brake. The system has 2 exhaust brakes. One at the front and one at the rear. The failed unit was the one located in front of the DPD which required complete replacement of the exhaust brake assembly.

A new exhaust brake was fitted and a successful regeneration was able to be performed, with truck reportedly running well.
