Subaru Diesel Secondary EGR Fault

By Clinton Brett

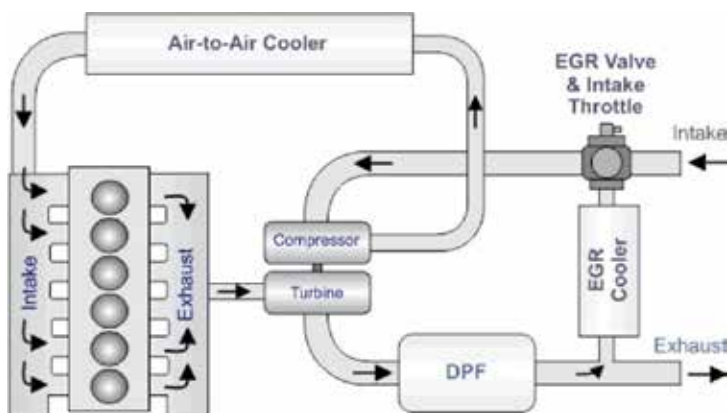
Low Pressure Loop EGR

This can also include connecting pipes, sensors, intake manifolds and EGR coolers. The secondary EGR system on a diesel is referred to as the Low Pressure EGR and is located after the Diesel Particulate Filter (DPF). This design is not somewhat a modern innovation. The USA heavy vehicle industry was using this in the early 2000's to assist reducing nitrogen of Oxides (Nox) at minimal expense compared to the more expensive system we are all very familiar with- AdBlue. The cost of storing AdBlue was the US government's biggest hurdle and key stakeholders came up with this Low Pressure (LP) EGR system as a cost-effective alternative.

One of the key features of this LP EGR is a fine gauze fitted in between the DPF and the EGR itself. The stainless steel gauze filter reduces excess carbon build-up around the EGR valve and EGR cooler. This can extend the service schedule for intake manifold cleaning.
