Fuel control valves ID diagnostics Part 3

By Clinton Brett

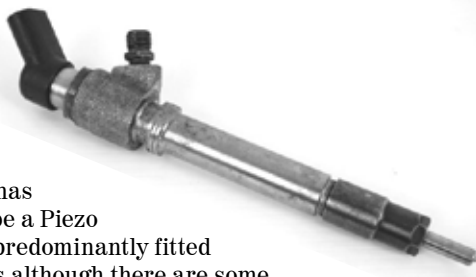
Pic 1 Early Continental Siemens injector

Originally developed by Siemens, the Continental injector has only been known to be a Piezo design injector. It is predominantly fitted to passenger vehicles although there are some found in commercial, just very few of them exist. Popular applications include Citroen, Ford (Ranger & Mazda BT50), Land Rover, Peugeot, later model Volvo- Most of which are made by the Ford/Peugeot engine design joint venture PSA. The continental injection system is also fitted to Renault engines who provide the platform for the popular Nissan NP300 Navara, Renault and Mitsubishi commercial vans, and the VAG group engines have a limited range using the continental injectors.

The Continental Piezo injector has not changed much since its first release in the late 90's. You can see in Pic 2 and 4 there is a slight change in the shape of the actuator and the return remains outside the cast body, the difference between the two is the female outlet has been redesigned to a male outlet. One of the reasons I believe this change occurred, is the fitting design of the early type is prone to leaking but also the return outlet of the later design, means the OEM plastic return fittings are similar, reducing costs to the OEM.

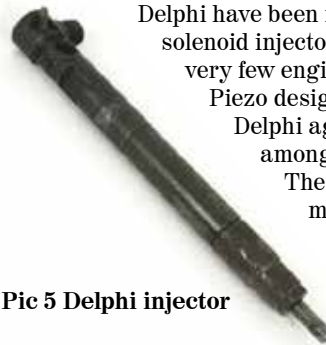
Pic 5 Delphi injector

Delphi have been manufacturing electromagnetic solenoid injectors from the late 1990's. There are very few engines that are fitted with a Delphi Piezo design. Back in 2008 as an authorised Delphi agent, we were informed of an issue amongst a newly released Mercedes.

The Delphi injectors were defective and experienced a high failure rate. The vehicle would enter limp mode or fail completely. In our experience, the root issue is a problem with the Piezo design from Delphi. Several cars experienced a random over revving of the engine which of course could end badly. Finally, Mercedes-Benz bit the bullet scrapping the piezo injectors for all vehicles powered by the OM651, replacing them with the electromagnet actuated solenoid injectors. This also meant a change to most of the system, including an updated ECU.

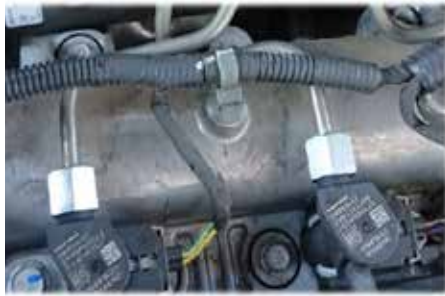
Pic 7 Delphi fitted to Holden Captiva

The most popular downloaded- TB1163–Holden Captiva failure to start after removing injectors. (2013 Holden Captiva 2.2L engine). A common mistake is following Delphi's official installation process for all CRD injector replacements. Unlike most of the other Delphi systems, which recommends unplugging the Suction Control Valve, the Captiva instructions we developed are slightly different and recommends unplugging the rail sensor. This enables the fuel system to reach maximum rail pressure, thus assisting to purge air from the system. We also advise to leave the injector electrically connected but isolate the fuel return to prevent air returning to the fuel filter.

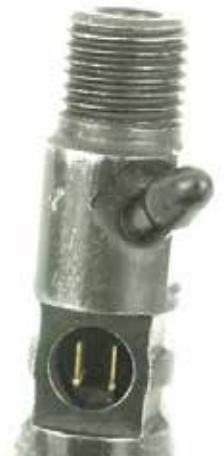
Pic 8 Delphi early design

The early design used a wire clip to secure to the body of the injector. The harness connector contains a Dust Seal which also

assists to retain rigid connection. If this seal is damaged or missing, a short can occur in the wiring and leave a carbon deposit on the connector and injector. Do not clean these engines with water or chemicals. Use an evaporative non-corrosive cleaner. If in doubt, replace the connector as the seals are not available separately.

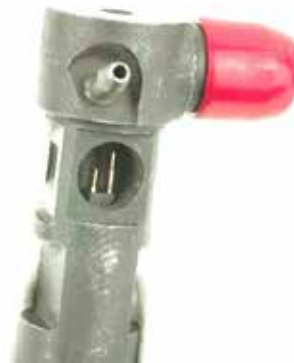
Pic 9 Later design Delphi injector

The later design Delphi has a distinctive change in the terminals. One is longer and the harness uses a secure lock feature. This has reduced the movement, but we have experienced issues after cleaning of the engine with water and detergents.
